## TSLOPE3

## OPEN PIT MINE EXAMPLE

This TSLOPE3 example is based on a slope failure in an open pit mine. The rock is a strongly foliated metamorphosed schist that has been extensively mineralised.

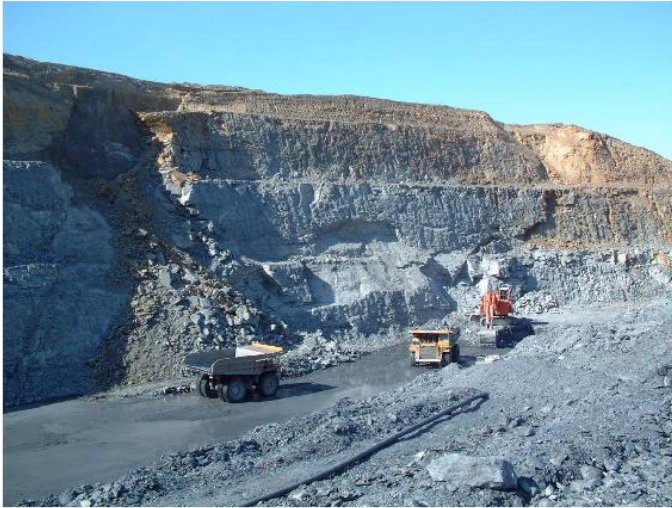
The slope failure was controlled by a number of clay-filled faults. The failure surface was modelled as a composite surface based on fault outcrop and projected orientations.

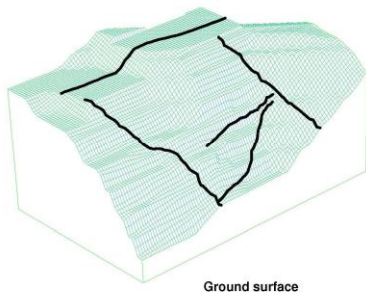
Ground surface

Topographical survey data were used for the top surface and the phreatic surface was estimated from recorded piezometric levels.

TECHBASE, a geological GIS software package, was used for generating the modelled surfaces and imported as ASCII (XYZ) gridded points into TSLOPE3

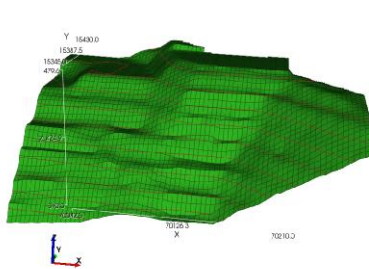
TSLOPE3 top surface

The surfaces were imported to TSLOPE3 as a 'cloud of points'.

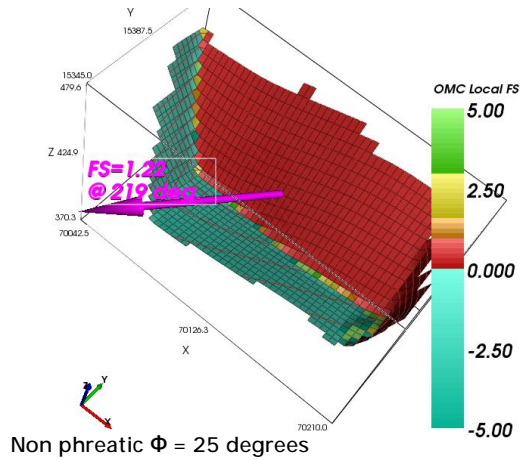
3D Cases	FoS	Direction
Dry - 15°	0.70	219
Dry - 25°	1.22	219
Phreatic - 15°	0.34	199
Phreatic - 25°	0.59	199

To estimate 'Factors of Safety' the default material properties were adopted. Two slope cases were analysed: one without a phreatic surface and one with a phreatic surface. The friction angle was varied and tested at 15° and 25°.

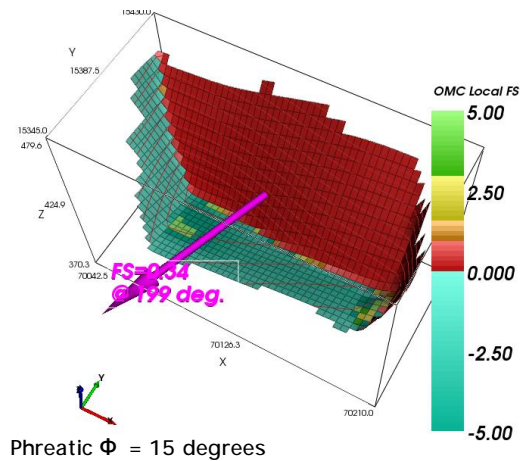
2D Cases	FoS	XS Bearing
Dry - 15°	1.10	193
Dry - 25°	2.32	193
Phreatic - 15°	0.95	193
Phreatic - 25°	1.66	193
